Some Problems With RIP-Insulated Bushings

Abstract—In this paper the possible reasons RIP-insulated high voltage bushing failures are investigated and discussed: first, factory technology defects, bushing test tap contact defects, mechanical strengthes in main insulation body, and a few another. With this in view, the authors have recommended on-site PD measurement and FRA technology as mandatory diagnostic methods; to revise construction contact last foil layer with a test tap; HV protect elements (capasitor, surge arrester) installation.

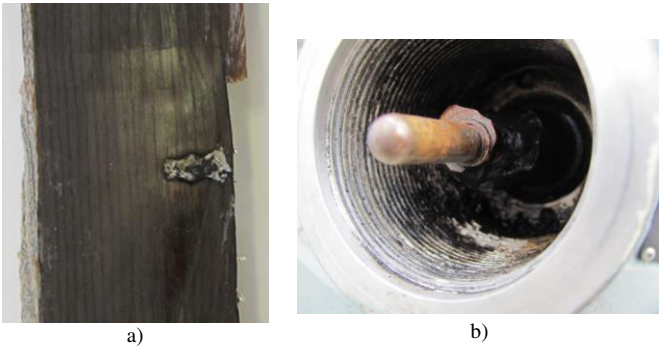
Insulation damage in the bushing central part reasons look clearer, especially in the area of test-tap contact to last plate (Fig. 1a). According to available statistics in Russia they occur in 70% of all failures. The main causes damage of this part are mostly of poor grounding quality, inefficient insulation protected against overvoltage and high transition resistance of contact connection test tap to last electrode. In case of bad grounding insulation test tap is damaged first (Fig. 1b).

Fig. 1. Examples of bushing damages: a) internal breakdown over 7 layers; b) ungrounding test tape - breakdown insulation.

Switching overvoltages on test output can occur when insufficient effectiveness of protective devices (capacitors, varistors, surge) or remote from the test tap location [2]. High transition resistivity is observed mainly in the bushings with spring design pin connection and is not seen at the last plate soldering wire connects guide her to the test tap.

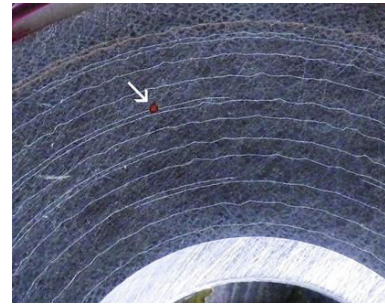
The purpose of this experiment was to establish the presence of through capillaries. The experiment was performed according to the method of 9.4.1 IEC 62217 [4]. Typically, each sample had one through the capillary (Fig. 3) and sometimes there were several. High painting liquid penetration rate (about 1 mm/sec) evidence of small capillaries diameters.

Fig. 3. Painted liquid penetration through capillary (arrow).

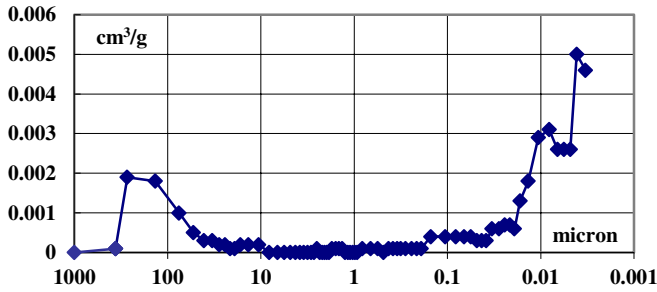
1. Left part of the curve can be explained not only by the presence of capillaries with diameters of tens and even hundreds of microns, but also be consequence of the uneven sample surfaces. Delamination of epoxy resin foil linings may

also be perceived as the equipment of large diameter capillaries.

2. Similarity central and right parts of the curves obtained on different samples indicates the stability properties of the internal structure. Thus small pore sizes are likely to belong to the crepe paper. Probably, during the manufacture of insulation they are not impregnated with epoxy resin due to counteract the surface tension forces. It should be noted that a large number of tiny capillaries leads to a large hygroscopic properties of conventional materials.

Fig. 4. Incremental volume (left axis) vs capillary diameter (lower) – graf (differential distribution).

Main authors' doubts in the test results associated with the preparation of samples: large diameter capillaries could appear not only in the process of impregnating the poor but also for cutting samples.

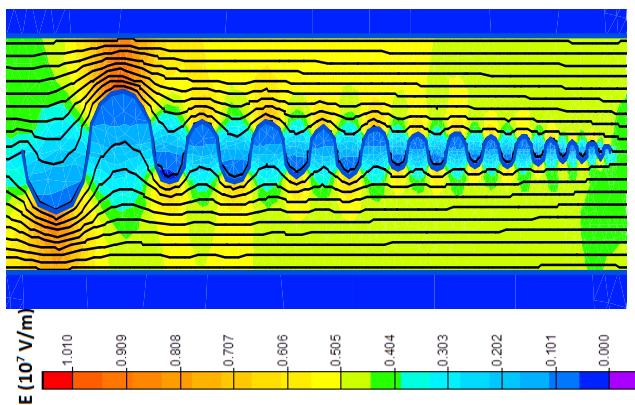
Fig. 5. Field pattern in two insulation layers with "hilly" middle electrode (plate).

The model parameters were: voltage electrodes from bottom to top 17.2 kV, 8.6 kV, 0 kV, distance between the plates - 2 mm, $\epsilon = 4$, tubercles radius varied in length sheath average from 1 to 0.1 mm. It can be seen local increase in strength caused by the irregularities are not so great to cause insulation breakdown directly subject to its quality. RIP

insulation electric strength is estimated over 30 kV/mm. With average field strength in insulation layers about 4 kV/mm, even doubling the local field enhancement caused by the roughness of the plates should not have been so radically (up to a few months) to reduce the bushing life.
