Some Problems With RIP-Insulated Bushings

Abstract—In this paper the possible reasons RIP-insulated high voltage bushing failures are investigated and discussed: first, factory technology defects, bushing test tap contact defects, mechanical strengthes in main insulation body, and a few another. With this in view, the authors have recommended on-site PD measurement and FRA technology as mandatory diagnostic methods; to revise construction contact last foil layer with a test tap; HV protect elements (capasitor, surge arrester) installation.

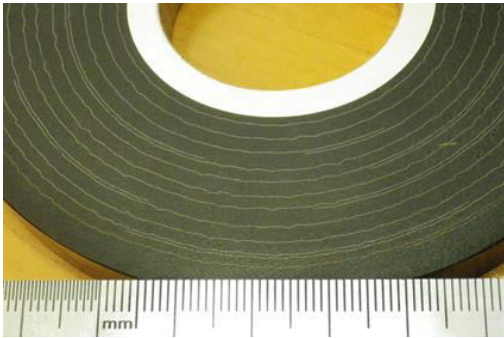
Fig. 2. Cutting example of RIP insulation.

The basis of porosity structure studies are behavior wetting and non-wetting liquids in capillaries. Liquid wetting the material which has a capillary it will rise. Conversely, liquid not wetting capillaries it will be omitted. In addition, the liquid height (lowering) depends on tube thickness: the thinner the capillary, the more lift height (lowering of) liquid. The studies were provided on RIP-insulation samples thickness of 10 ± 1 mm, cut by diamond blades from bodies 110 kV bushings of Russian production with great caution (Fig. 2).

Irregularities plates arise due to irregularities in crepe paper and clearly seen in Fig. 2. Electric field calculations were carried out in model of two insulated layers separated by irregular plate. Example electric field pattern in the model shown in Fig. 5.
